COCHREN

Foundation Wall Replacement

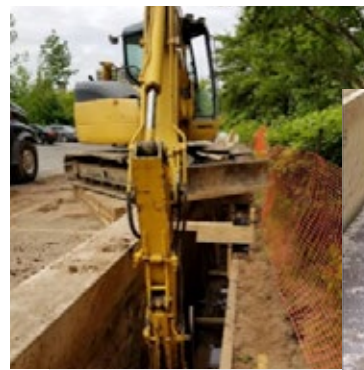
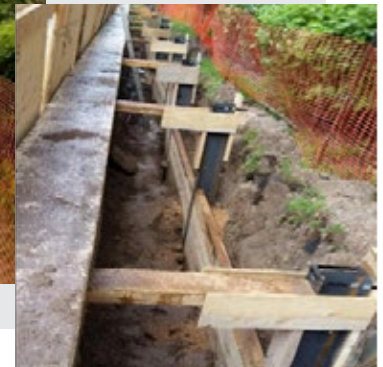
The foundation walls of the underground parking structure was constructed with unreinforced masonry block. The clay soil adjacent to the wall became saturated as result of poor grading, clogged weeping tile and close proximity to the underground sprinkler system. Over time the expansive clay soils and frost pushed the perimeter wall inwards.
