The effects of Frost Adhesion on homes.

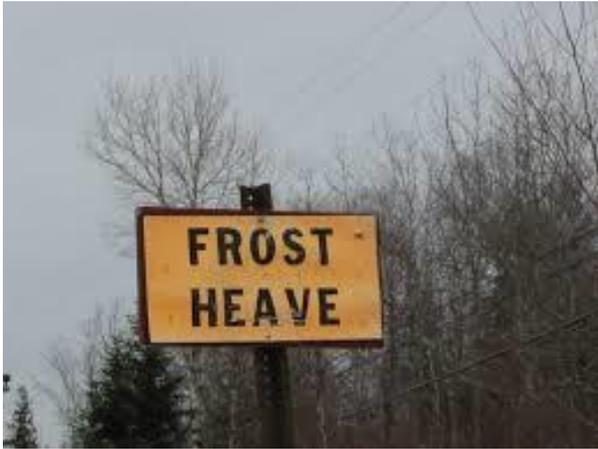
In our area, footings are buried 4'-0" feet in the ground to prevent frost from going underneath and lifting the home. With Frost Adhesion, the ice actually attaches itself to the side of the foundation wall forming a bond strong enough to lift the home upwards.

Distortion is caused by unequal lifting around the garage or cold cellar, causing doors and windows to become inoperable, a 2" difference across the top of a door way is not uncommon. Large step cracks occur in the brick veneer and concrete floors typically heave and crack,
